# Manhole Inspection Summary

Manhole # S31OO1006MH

Insp Date: **8/1/08 12:41 PM**

**Location** Address: **4501 CHARLES ST**

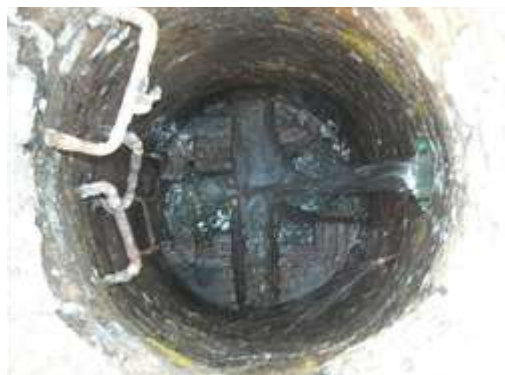
Top View

Corroded steps. Evidence of surcharge - Bench deterioration and debris.

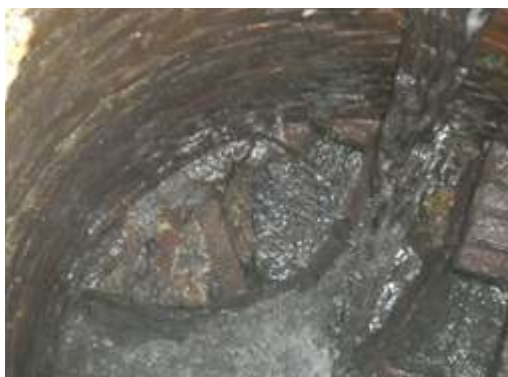
Defect

Bench deterioration.

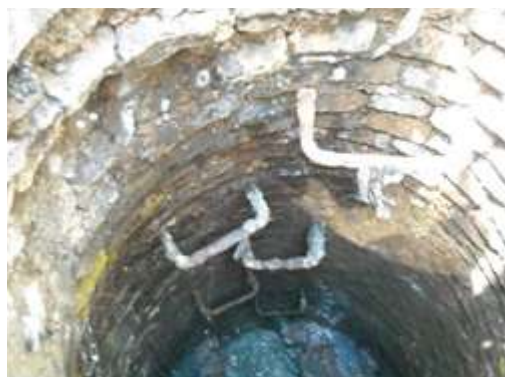
Defect

Frame leaks. Corbel deterioration and infiltration. Barrel infiltration.

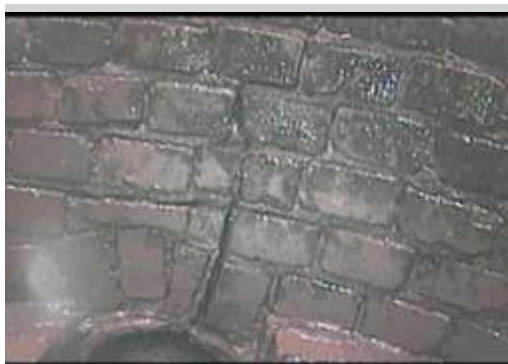
Defect

Barrel cracks and infiltration.

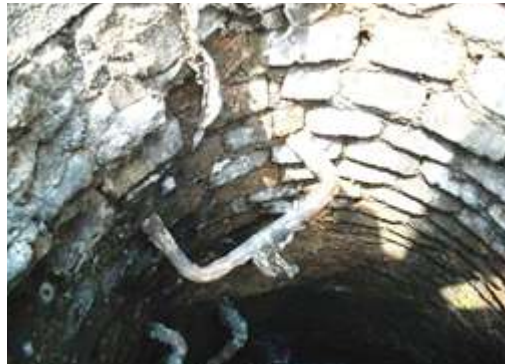
Defect

Frame leaks. Corbel deterioration and infiltration.

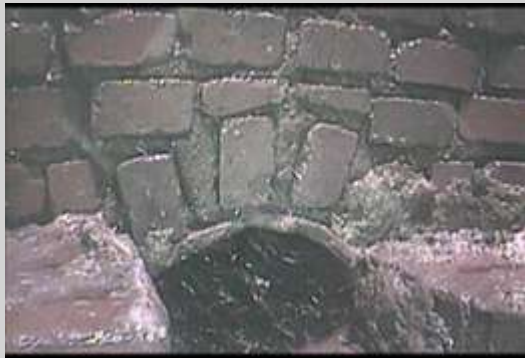
### 10 in. Circular Gravity Sewer Pipe Out @ 12 O'Clock

Barrel deterioration and infiltration.

Infiltration: **None** Pipe Seal Cond: **Cracked**

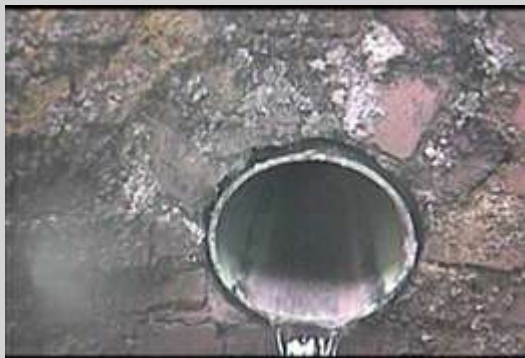
### 8 in. Circular Gravity Sewer Pipe In @ 3 O'Clock

Deposits: ☐ None ☐ Mud ☒ Sludge ☒ Debris ☒ Grease

Silt Depth: **3** (in.) Deposits Extent: **Medium**

Infiltration: **None** Pipe Seal Cond: **Broken**

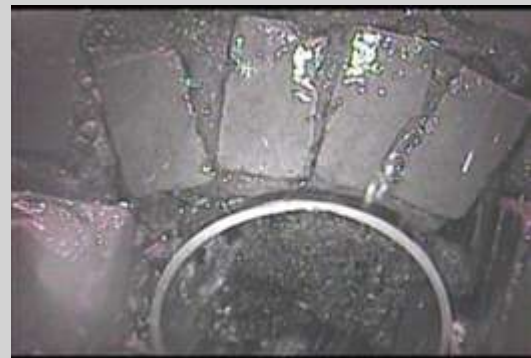
### Drop In @ 3 O'Clock

Drop Condition: **Partly Clogged**

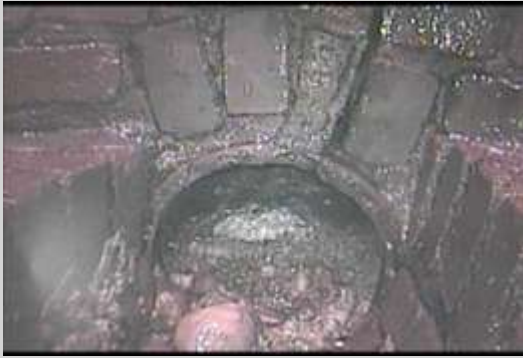
### Pipe In @ 6 O'Clock

Channel deterioration.

Pipe Material: ☐ Pipe Lined  
Invert Depth: (ft.) Flow Characteristics: **None**  
Deposits: ☒ None ☐ Mud ☐ Sludge ☐ Debris ☐ Grease  
Silt Depth: (in.) Deposits Extent:  
Infiltration: **None** Pipe Seal Cond: **Cracked**

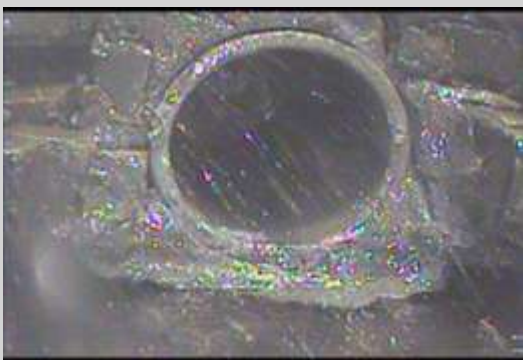
#### Pipe In @ 9 O'Clock

Pipe Material: **Clay** ☐ Pipe Lined  
Invert Depth: **10.20** (ft.) Flow Characteristics: **None**  
Deposits: ☒ None ☐ Mud ☐ Sludge ☐ Debris ☐ Grease  
Silt Depth: (in.) Deposits Extent:  
Infiltration: **None** Pipe Seal Cond: **Cracked**
